Hydrilla Monitoring Summary

Finger Lakes Marine Service

Cayuga Lake, Lansing, New York

2021

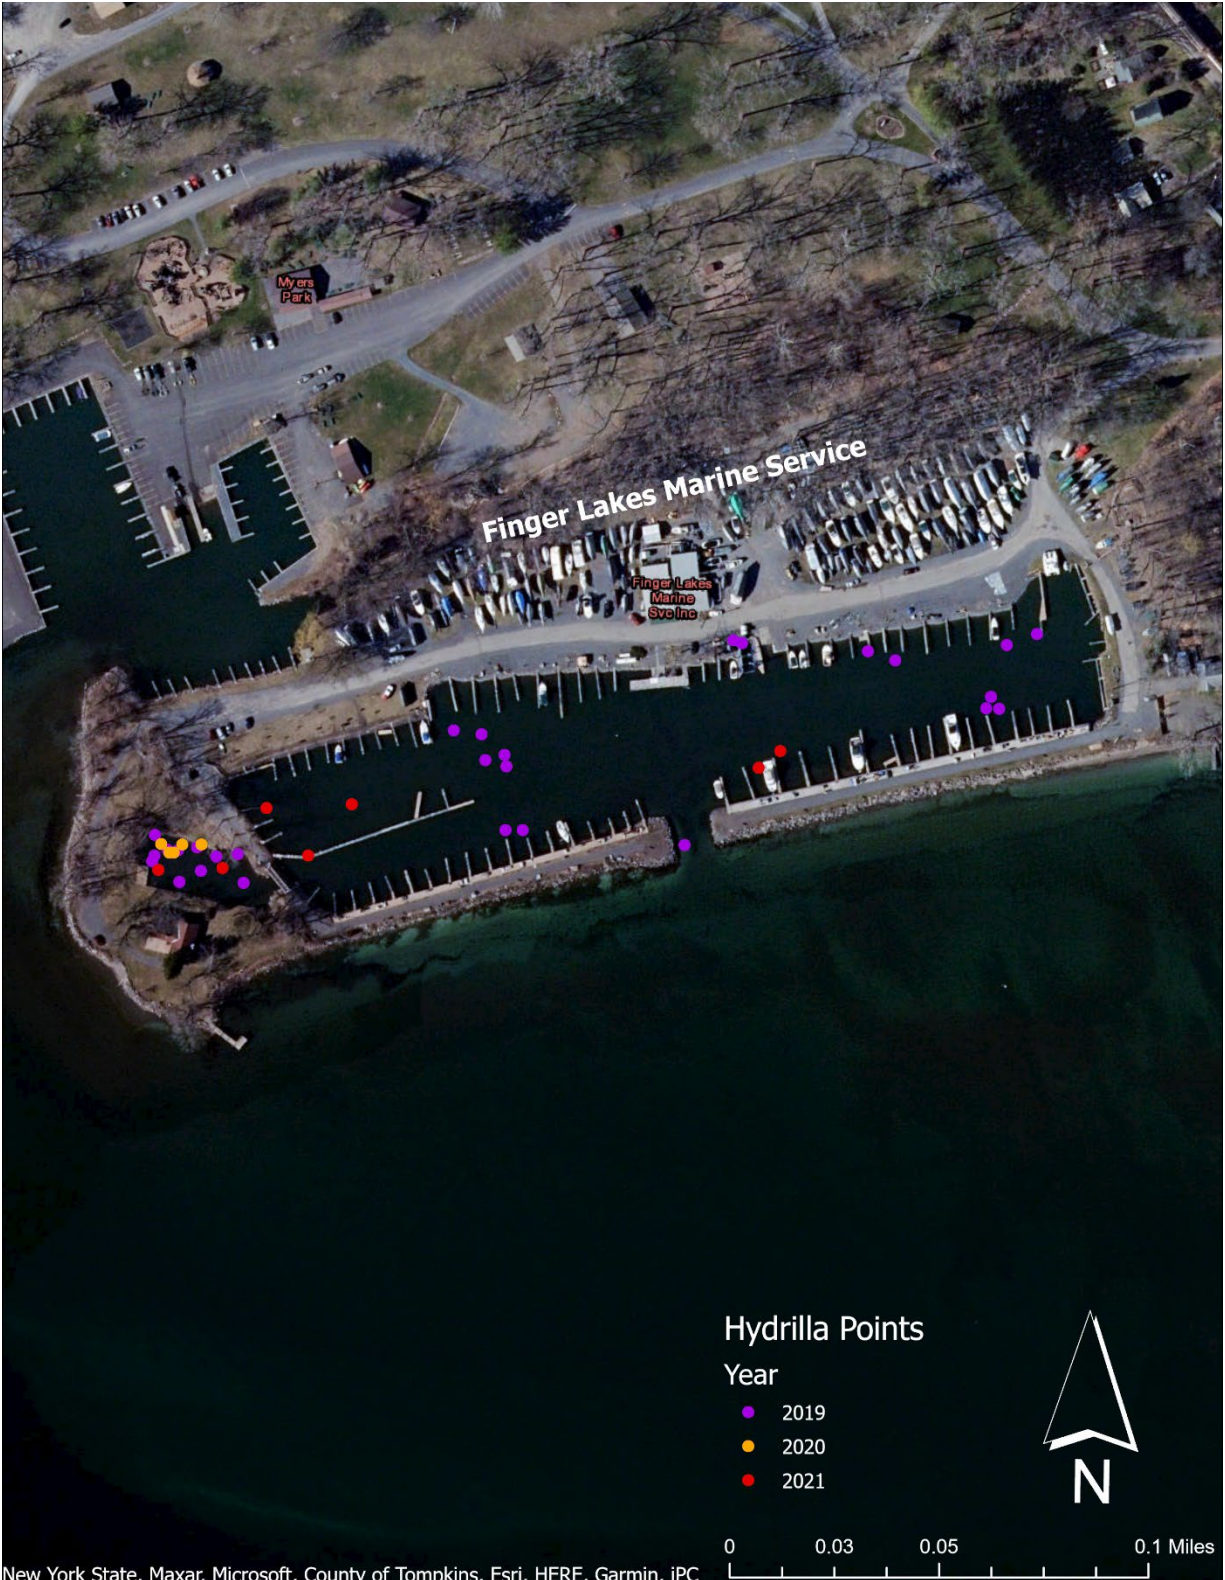
Figure 1. Hydrilla detections in Finger Lakes Marine Service, Lansing, NY.

A Hydrilla population was discovered in a private marina, located in Lansing, Tompkins County, NY, late August of 2019. Patches of Hydrilla were growing throughout a 5-acre area consisting of the enclosed marina and a small, connected pond (Figure 1). This site has received three years of chemical control; a copper-based herbicide (Harpoon Granular) was utilized in October 2019, and fluridone (Sonar H4C) was applied the following summers.

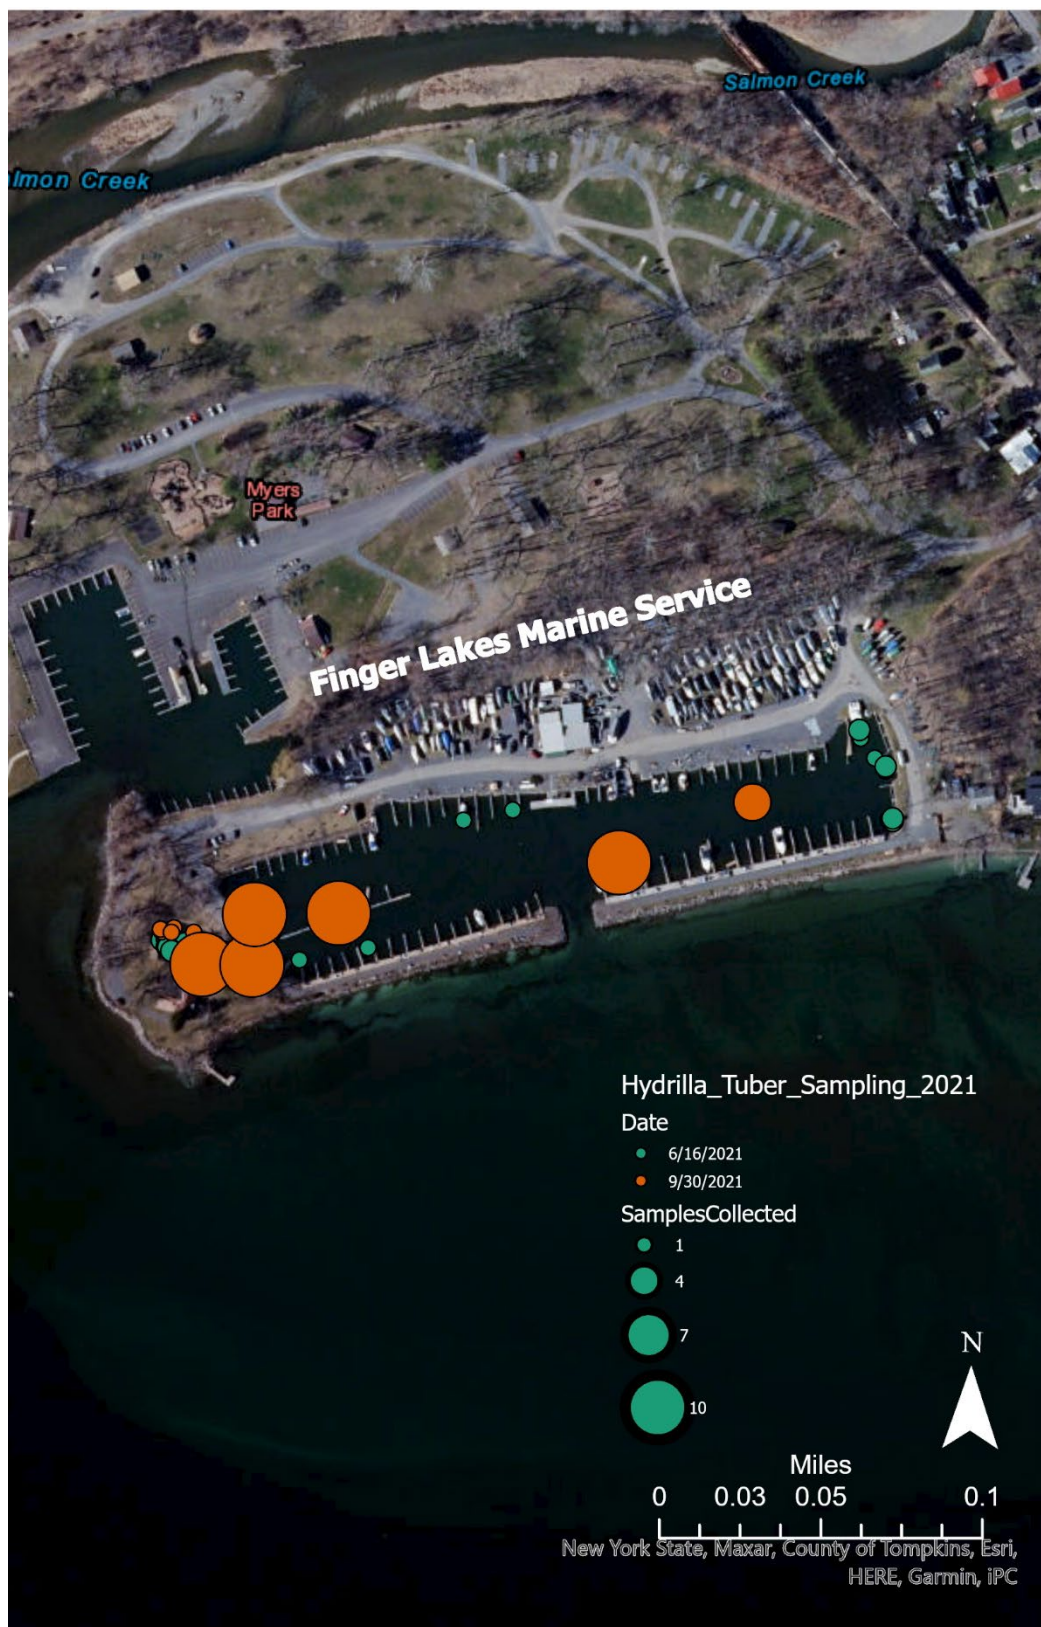
Figure 2. Tuber sample locations in the Finger Lakes Marine Service treatment area, Lansing, NY, in 2021.

Tuber sampling was performed June 16 and September 30, 2021. A post-hole digger was used to collect sediment samples in locations where Hydrilla had been previously observed. Sampling in June occurred in areas the field team was able to reach the sediment from a jon boat, so points were restricted to the edges of the marina and throughout pond due to water depth. The handles of the post-hole digger were extended for the September sampling and the field team was able to sample deeper water depths. In total, 105 sediment samples were collected (44 in June and 61 in September, Figure 2). No Hydrilla tubers were found during either sampling event.

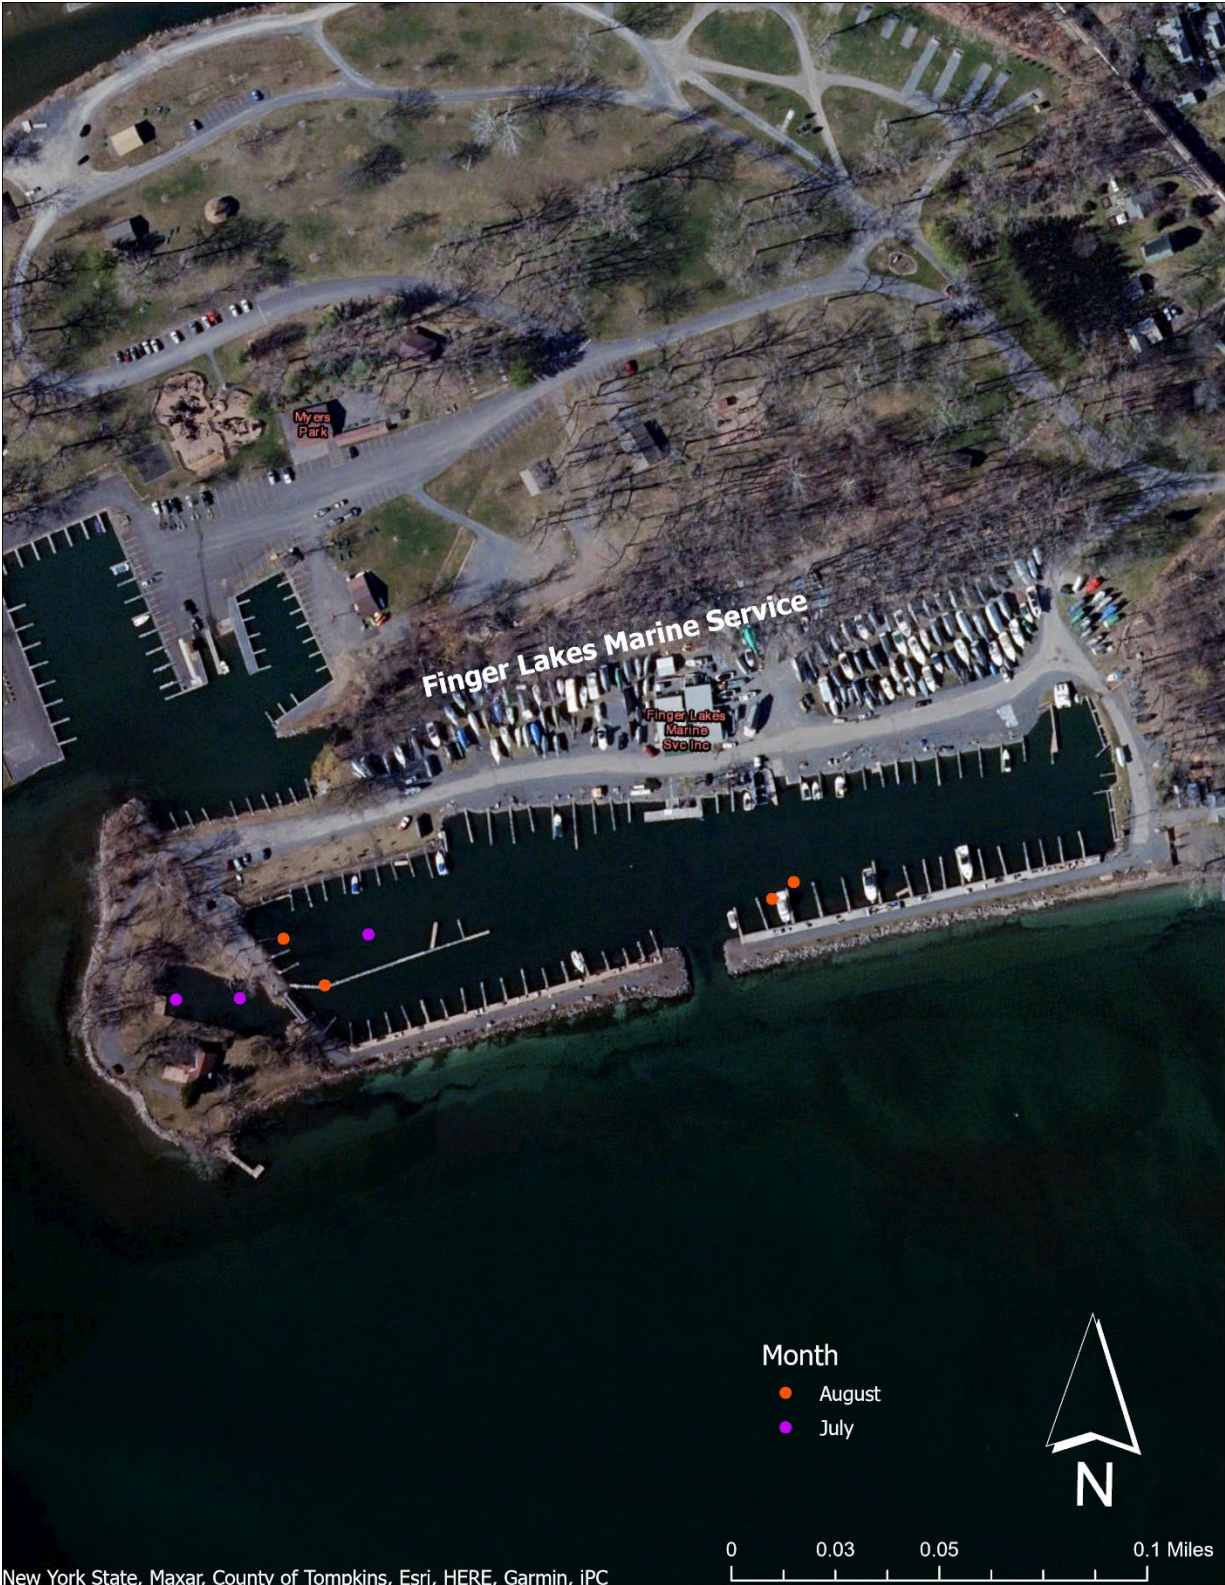
Figure 3. Hydrilla detections in Finger Lakes Marine Service, Lansing, NY during the 2021 field season.

Plants were monitored throughout the growing season using the rake toss method. Sampling occurred weekly from June 9, 2021- September 15, 2021, then every other week until October 29, 2021. Hydrilla was observed only within the treatment area, on July 21, July 28, August 18, and August 25 (Figure 3). No Hydrilla was detected afterward. Throughout the growing season, 2,521 rake tosses were done within the marina or within a point-intercept survey around the marina and proximal waterbody access points, including the Meyer's Park boat launch and Salt Point (Figure 4). Within the entire survey area, the majority of rake tosses returned zero or trace densities. Within the treatment area, the most frequently observed species was the native coontail, while American eelgrass was most frequently observed species outside of the treatment area (Figures 5, 6).

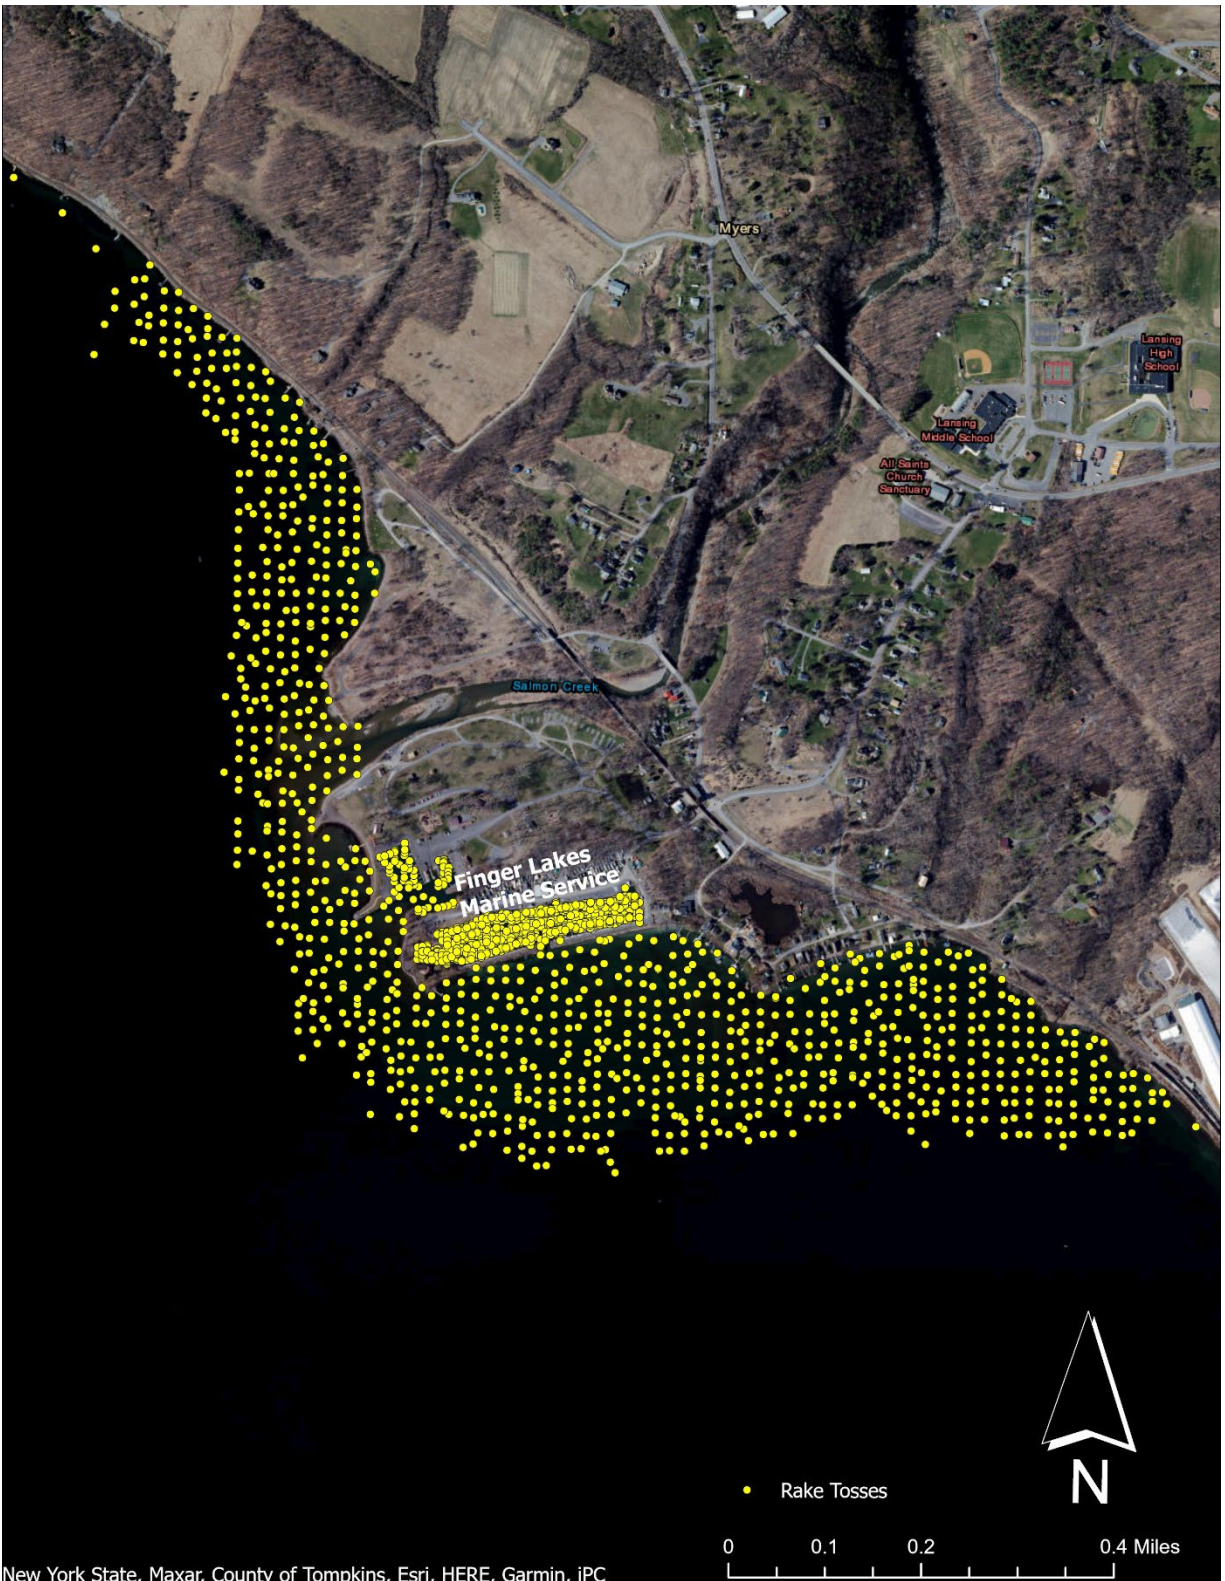
Figure 4. Rake toss locations during the 2021 field season, within and around the treatment area.

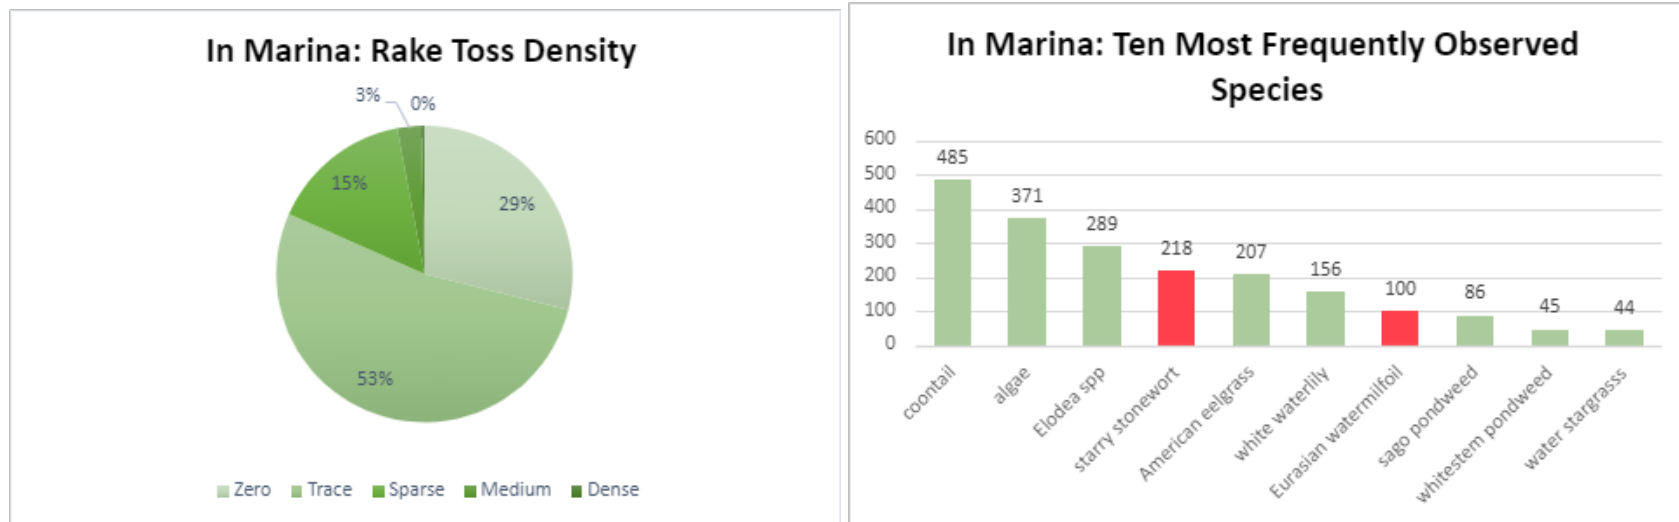
Figure 5. Rake toss densities and ten most frequently observed species observed within the treatment area in 2021.

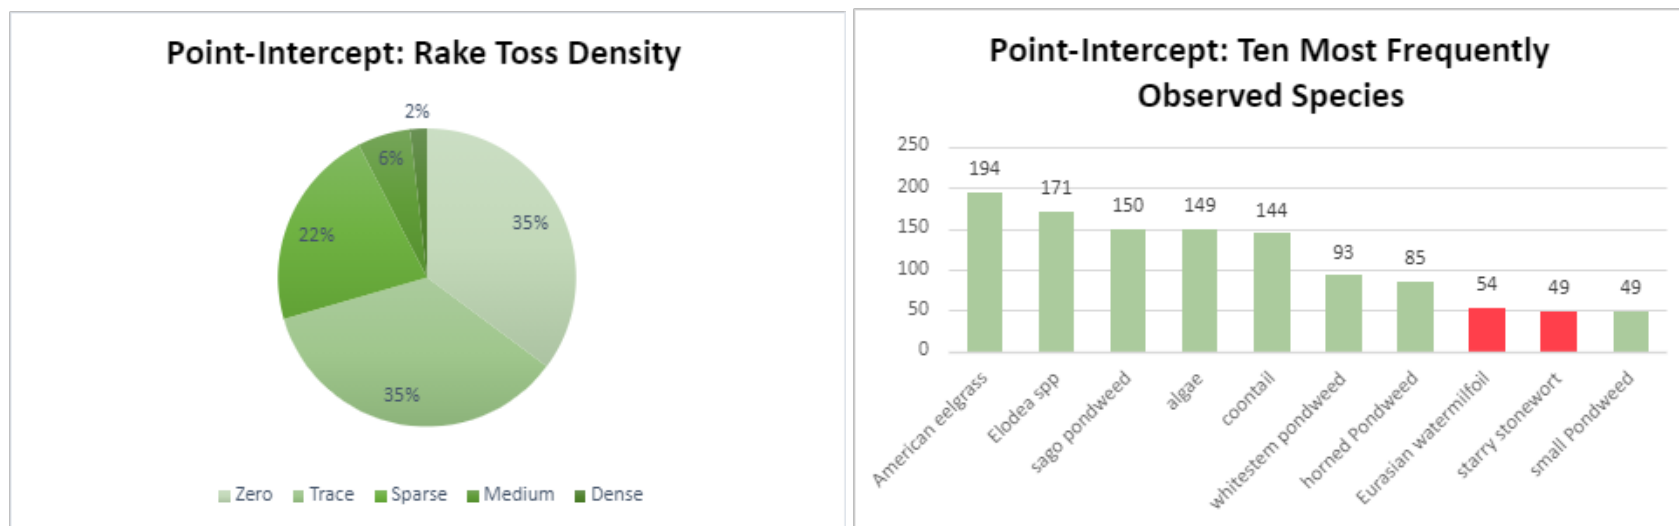
Figure 6. Rake toss densities and ten most frequently observed species within the point-intercept survey surrounding the treatment area.
